Limited Asbestos Survey Report

Sun Chief Mill Site - Trailer
Southeast Corner of Arizona Highway 77 & US 70
Globe, AZ

CSC Project # 5002357

Inspection Dates: January 26-27, 2010

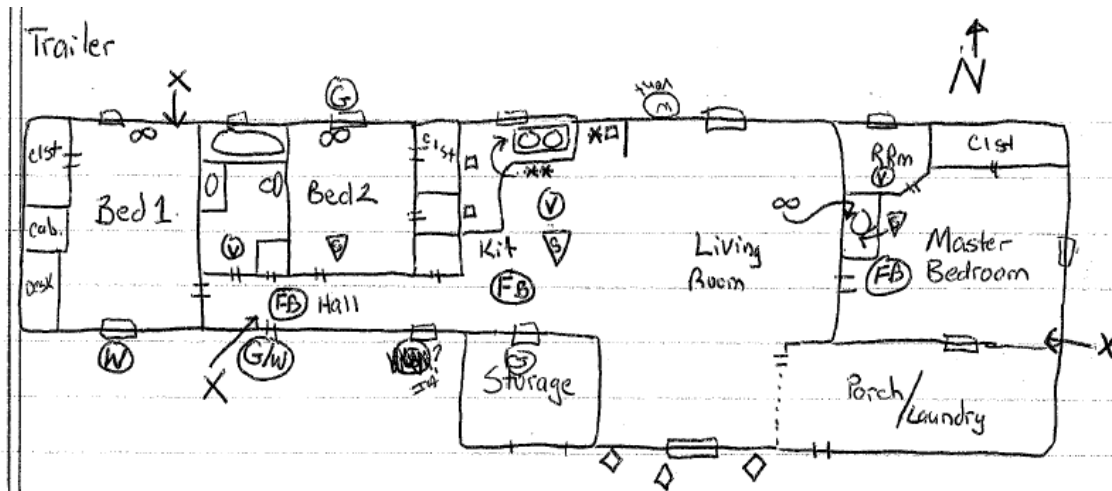
9. Site Diagram

- ⊙ = Gray Window Putty
- ⊙ = White Window Putty
- ⊙ = White 1x1 VFT
- ⊙ = White Fiberboard Ceiling
- * = Black Mastic (Interior Floor Penetrations)
- = Red Decorative Brick w/ Black Mortar
- ▽ = Bg Vinyl Sheet Flooring
- ∞ = White and Gold Wallpaper
- ◇ = Roof Layers
- X = Black Roof Mastic w/ White and Silver Paint

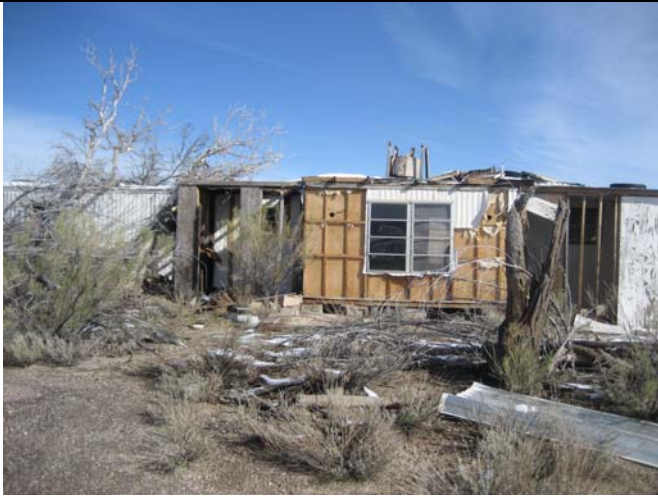
Photo 1: Trailer – subject property south elevation

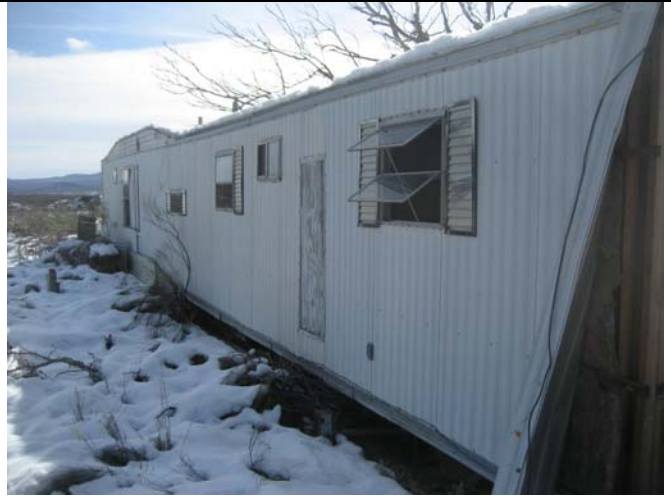
Photo 2: Trailer – subject property north elevation

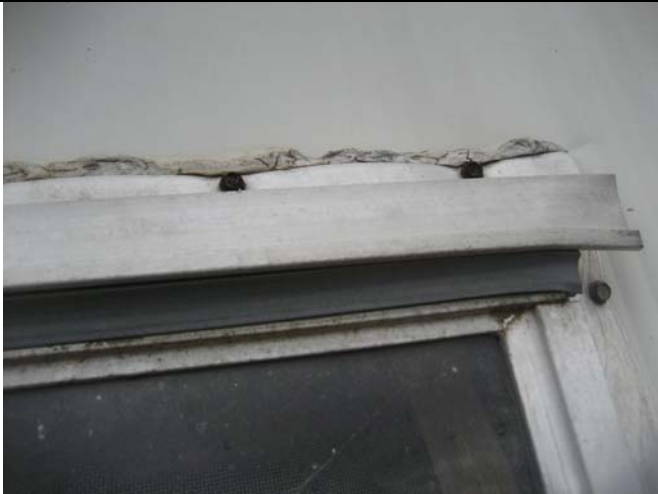
- **Black Interior Penetration Mastic** (kitchen); 5-7% chrysotile
 - ~3 square feet
- **White Exterior Window Putty**; 2-3% chrysotile
 - ~15 square feet
- **Gray Exterior Window Putty**; 30-35% chrysotile
 - ~ 15 square feet
- **Silver and White Exterior Paint**; 10-12% chrysotile
 - ~930 square feet

1. Interior Black Penetration Mastic (~ 3 square feet) located in the kitchen contained asbestos. The material is considered category II non-friable ACM.
2. White and Gray Exterior Window (and door) Putty contained asbestos. The material is considered category II non-friable ACM.
3. Silver and White Exterior Paint on the roof (applied over black mastic) contained asbestos. The material is considered category II non-friable ACM.
4. Category of asbestos may change due to the means employed by the contractor to remove ACM.

Photo 3: Example of window putty – positive for asbestos content

1. If suspect asbestos containing materials other than those tested are encountered, they must be assumed to contain asbestos or tested and proven otherwise.
2. Removal of category II non-friable ACM throughout the subject property should only be performed by certified asbestos abatement workers.
 - a. Removal by hand means shall be considered class 2 work.
 - b. Removal by mechanical means shall render the asbestos RACM.
 - c. Workers performing said work should comply with all state, local and federal regulations.
3. CSC should be contracted to write specifications prior to abatement and renovation activities at the subject property.
4. The contractor should be responsible for verifying locations and quantities of ACM.
5. A complete copy of this survey must be kept on site during asbestos abatement activities.

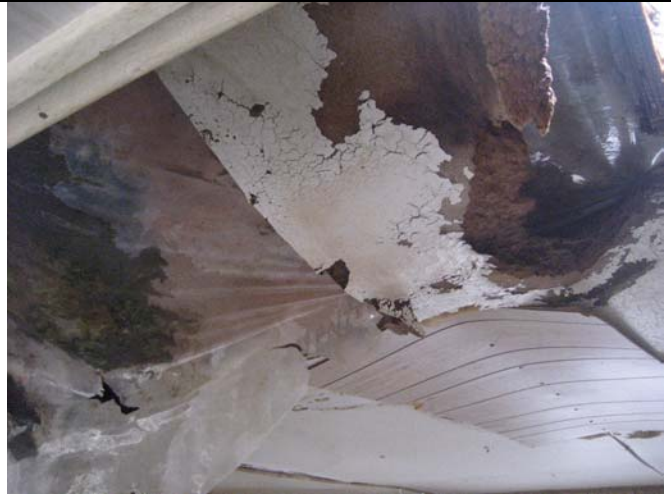
Photo 4: Example of fiberboard/texture coat – negative for ACM

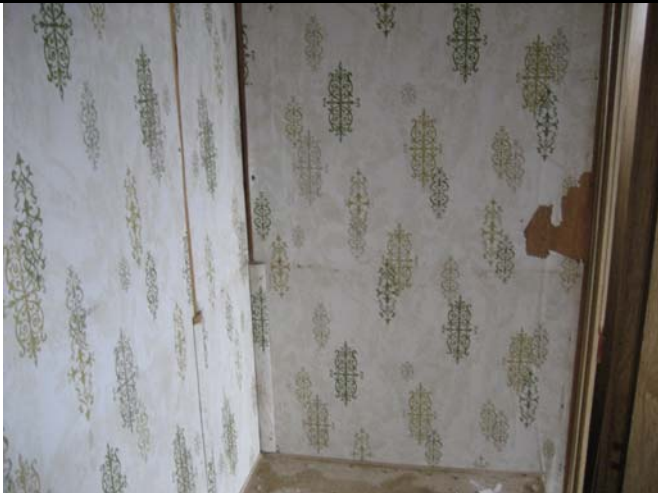
Photo 5: Example of white/gold wallpaper – negative for ACM

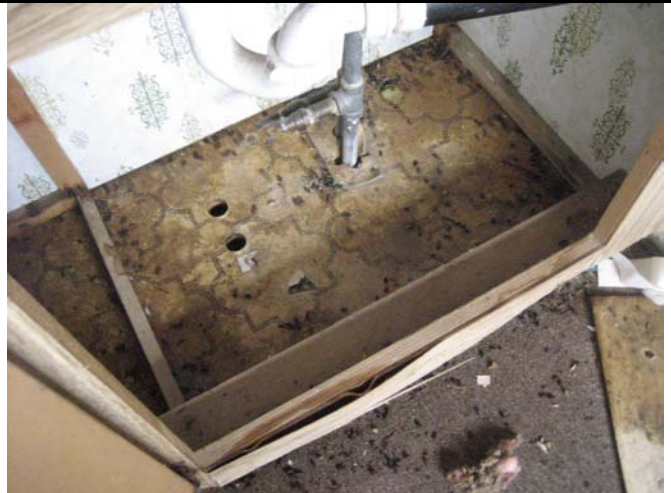
Photo 6: Example of beige vinyl sheet flooring – negative for ACM

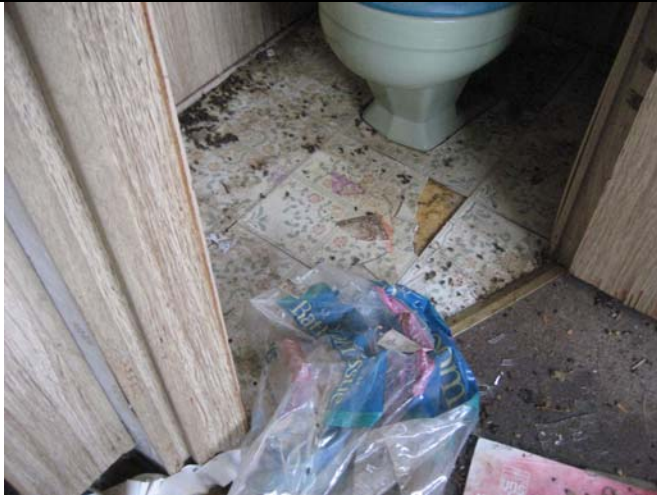
Photo 7: Example of 1'x1' VFT – negative for ACM

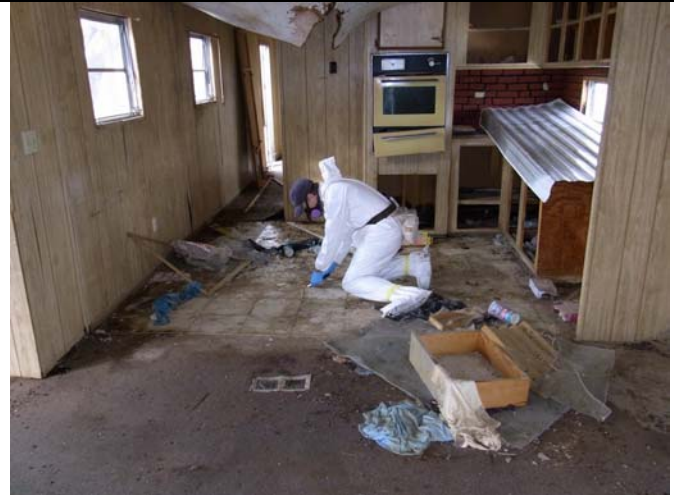
Photo 8: Example of bulk sample collection of the kitchen VFT and vinyl sheet flooring
